# Wadsworth Fire Station Study

Wadsworth, Ohio

December, 2016

Architect's Project No. 16096  
January, 2017

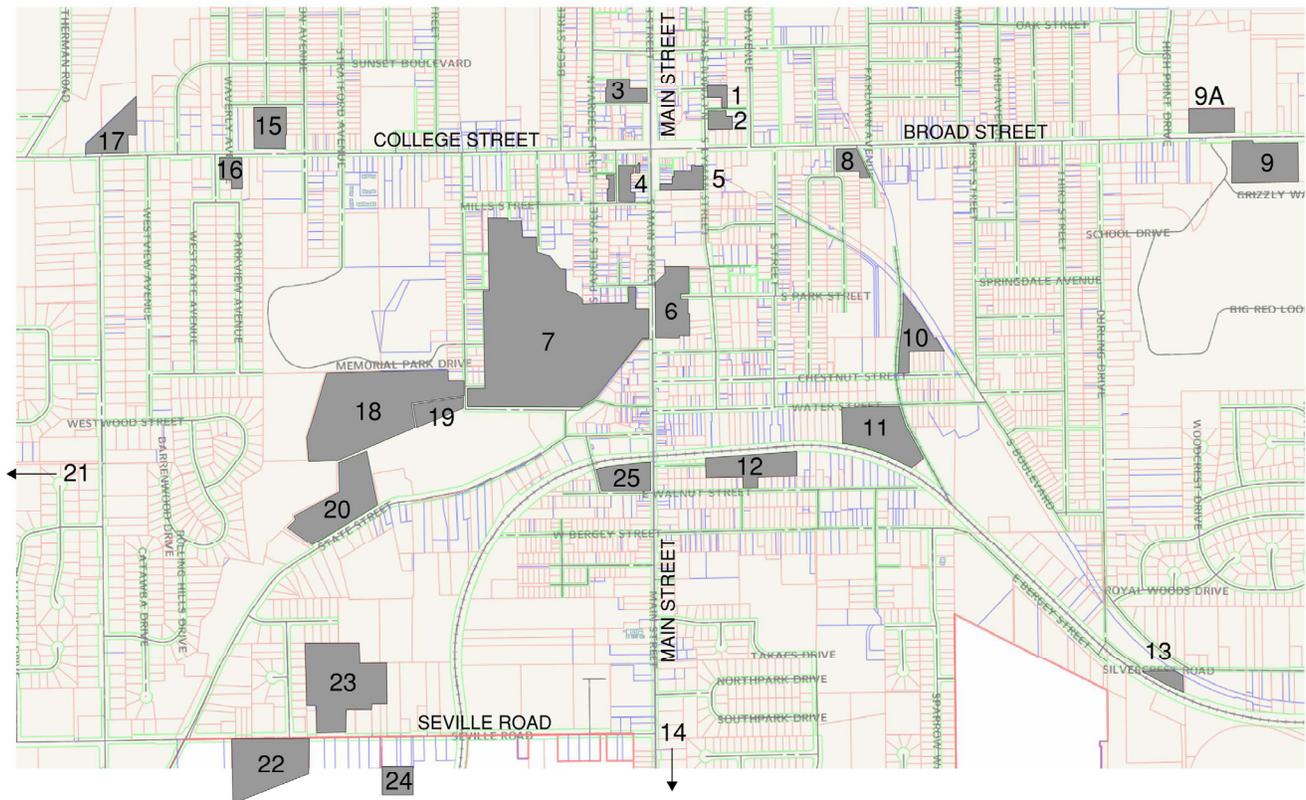
**Figure III-1: All Potential Sites**

After review, the potential sites were narrowed down to 12. A facility and site development diagram was prepared for each, to see how the fire station could operate on the site. In addition, emergency vehicle response time diagrams were prepared for each site indicating both 4-minute and 8-minute response times. These were overlaid with the same response time measures from Fire Station 2.

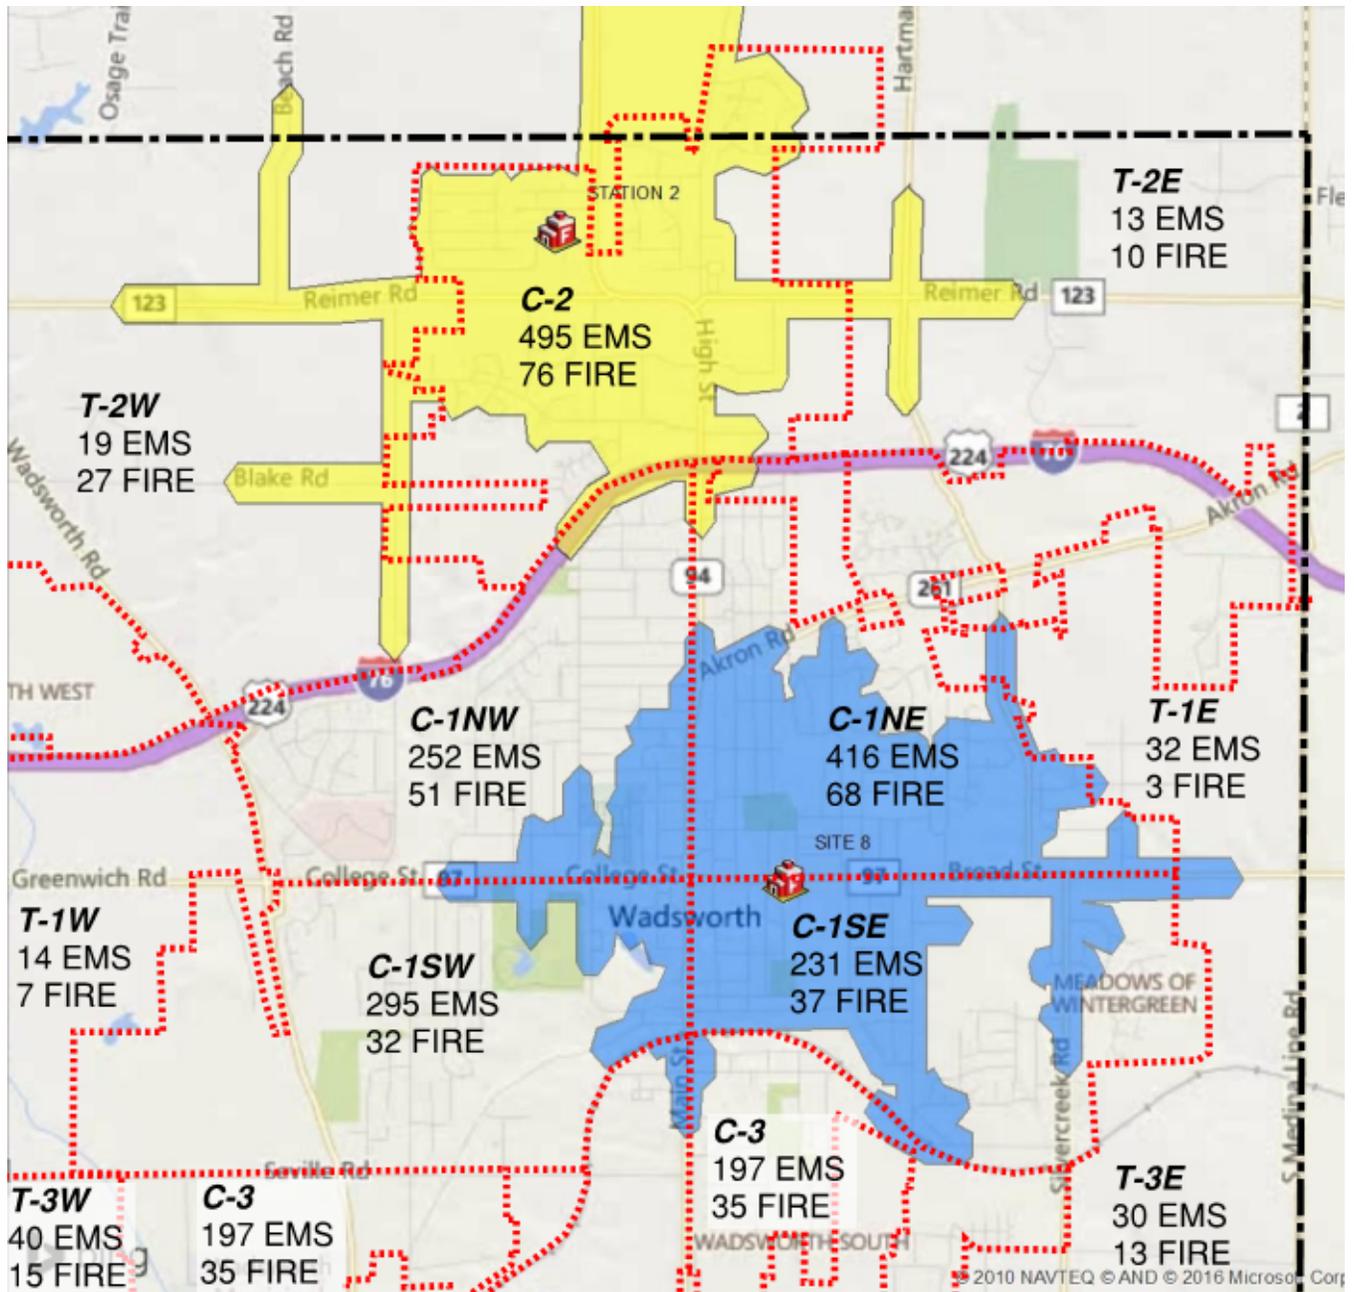
Site 8: 4-Minute Response Time

4-MINUTE RESPONSE TIME

STATION 2

SITE 8

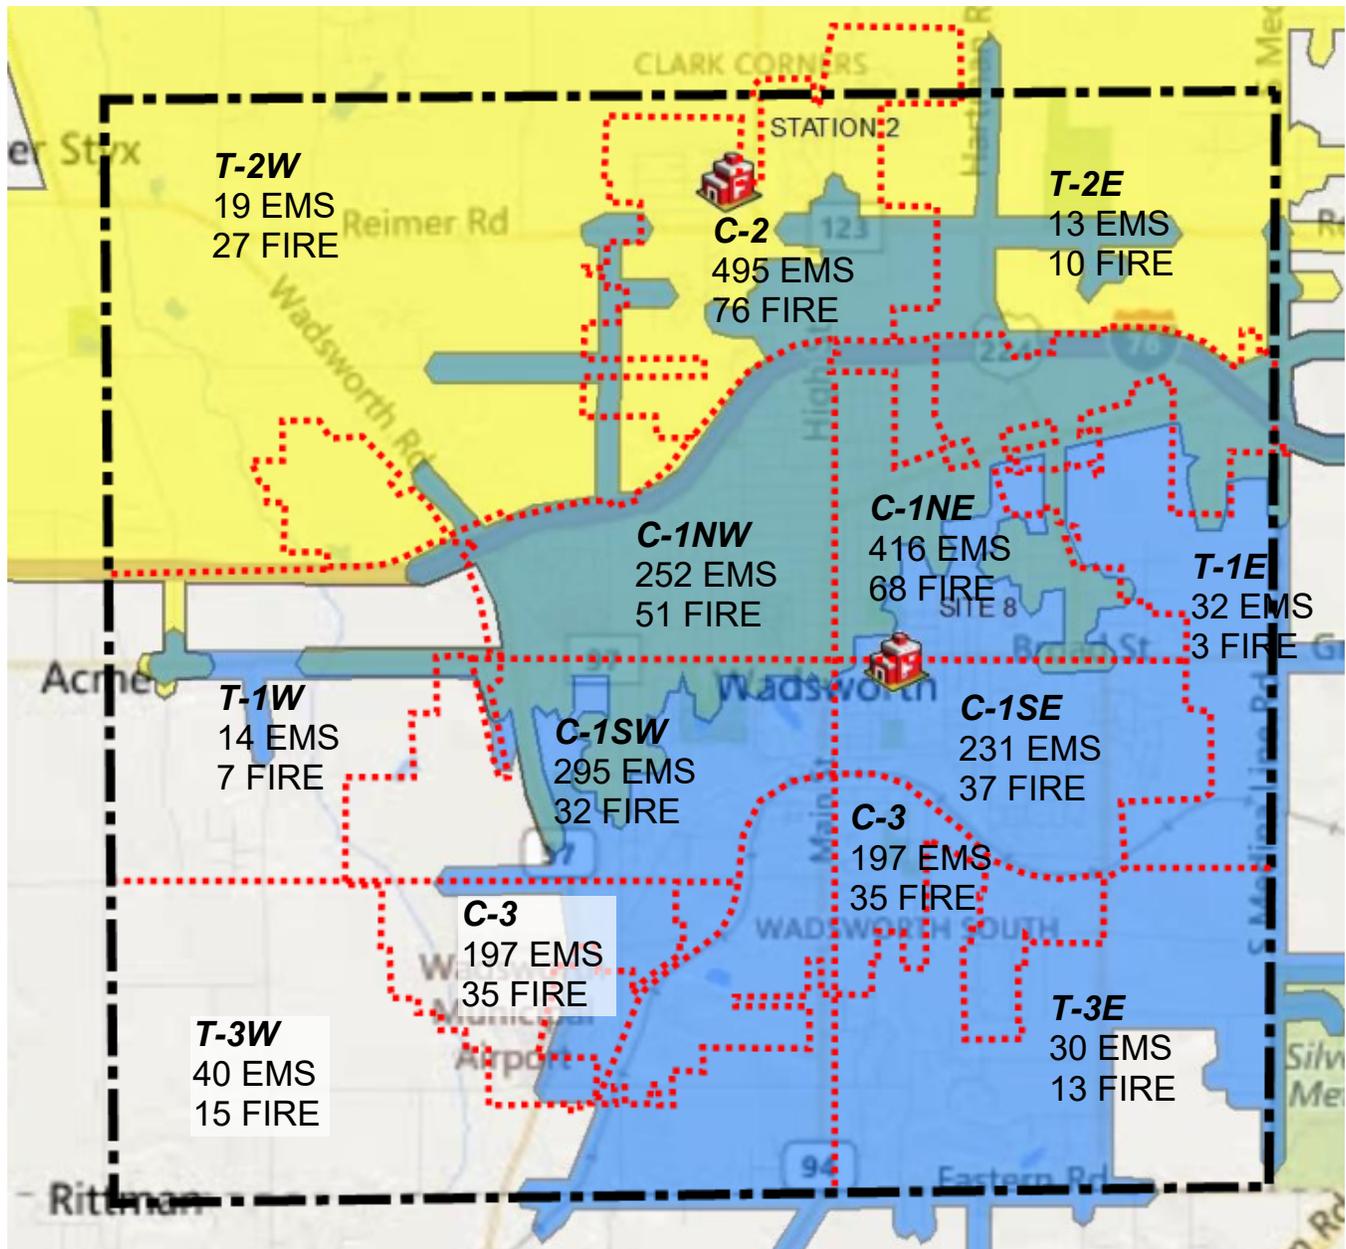
Site 8: 8-Minute Response Time

8-MINUTE RESPONSE TIME

- STATION 2
- SITE 8

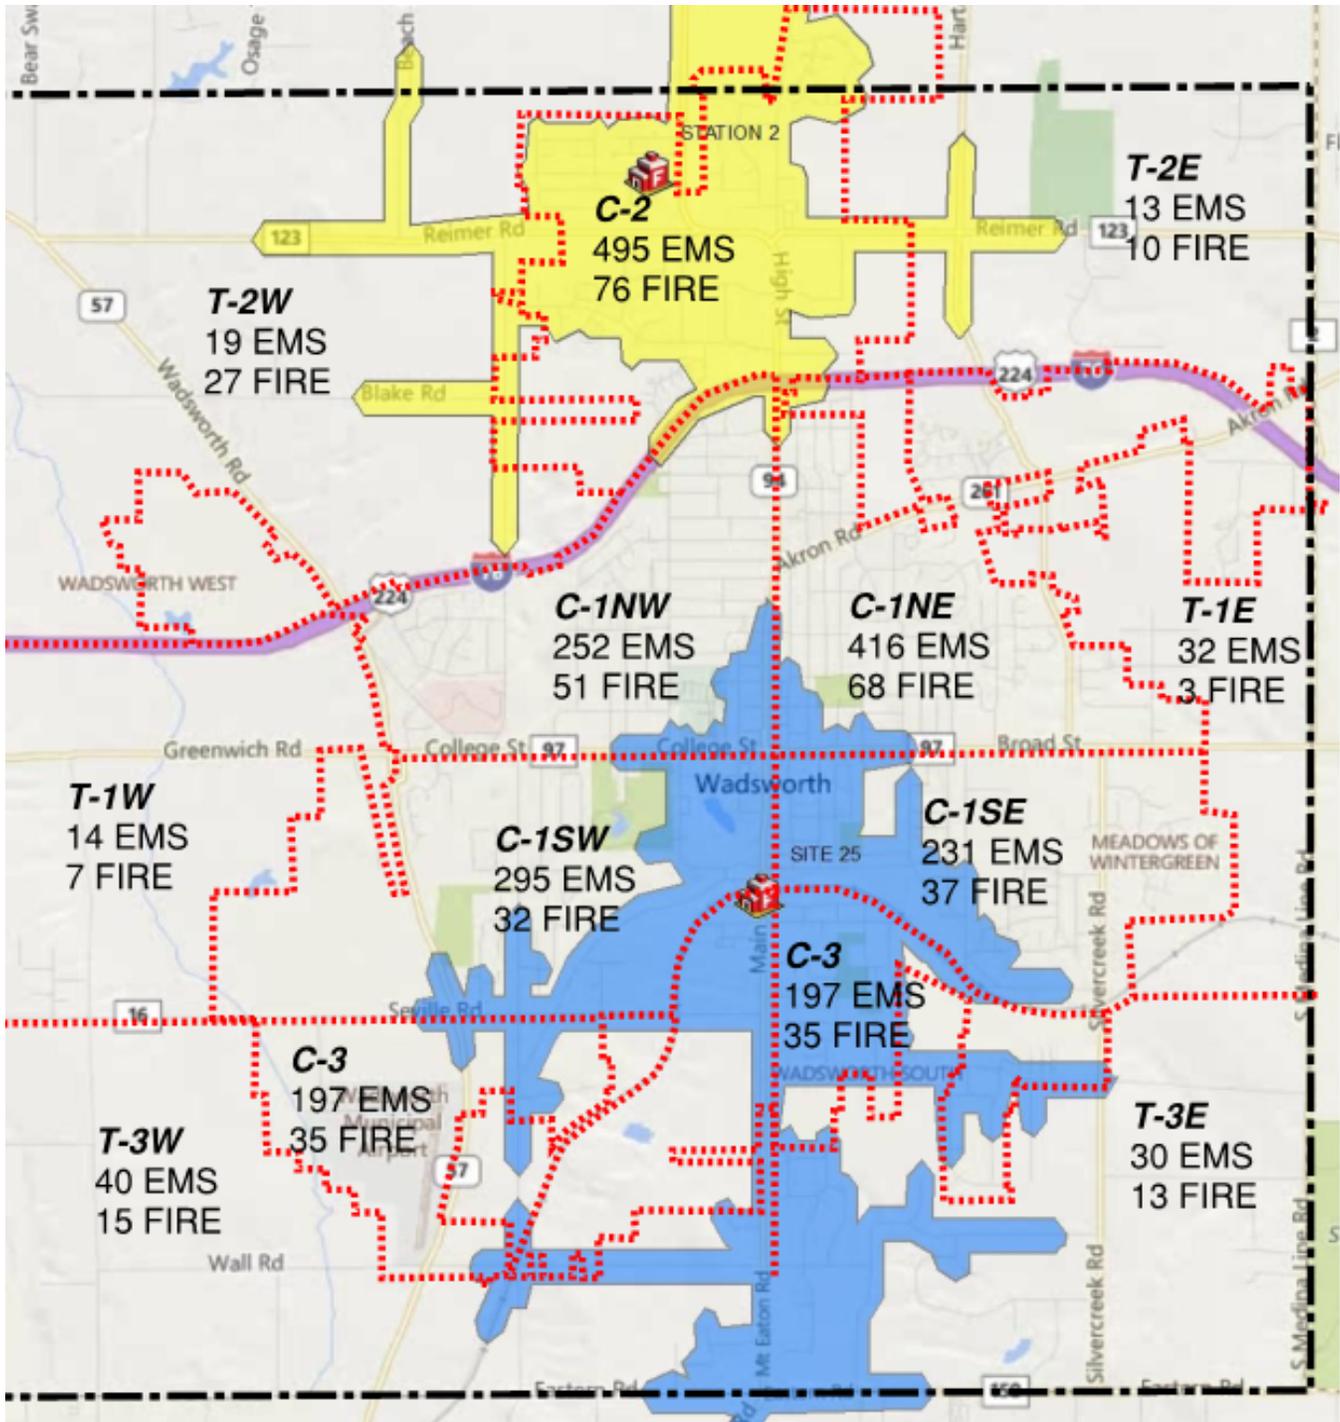
Site 25: 4-Minute Response Time

4-MINUTE RESPONSE TIME

STATION 2

SITE 25

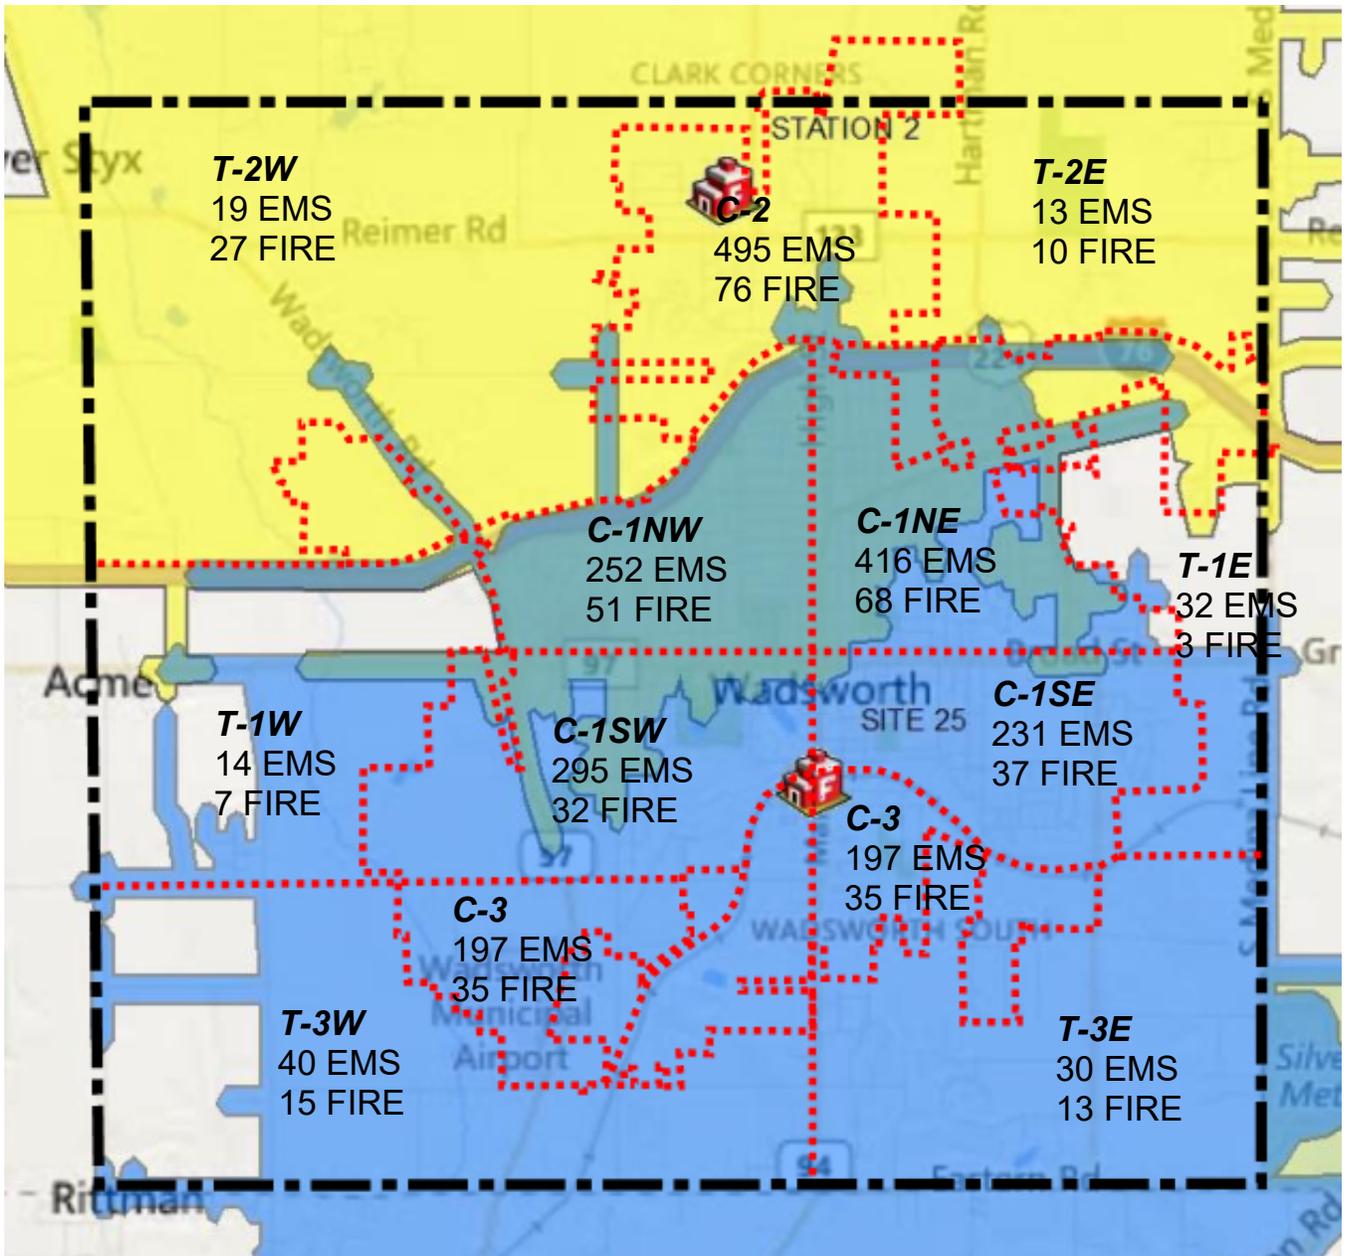
Site 25: 8-Minute Response Time

8-MINUTE RESPONSE TIME

STATION 2

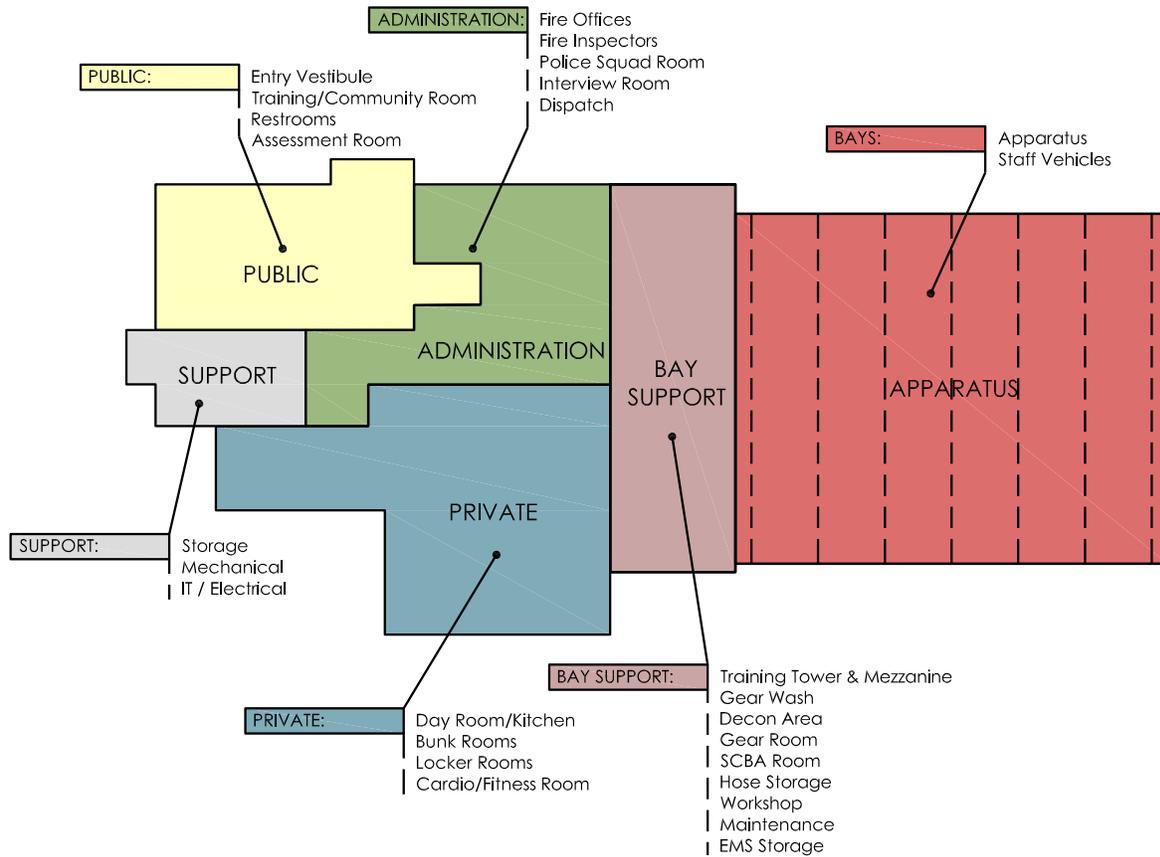
Figure IV-1: One Story Diagram

The floor plan diagrams provide an appropriate footprint that should be allowed for each site. The floor plan diagrams below indicate the primary spaces in the building. Please see Appendix E for detailed diagrams.

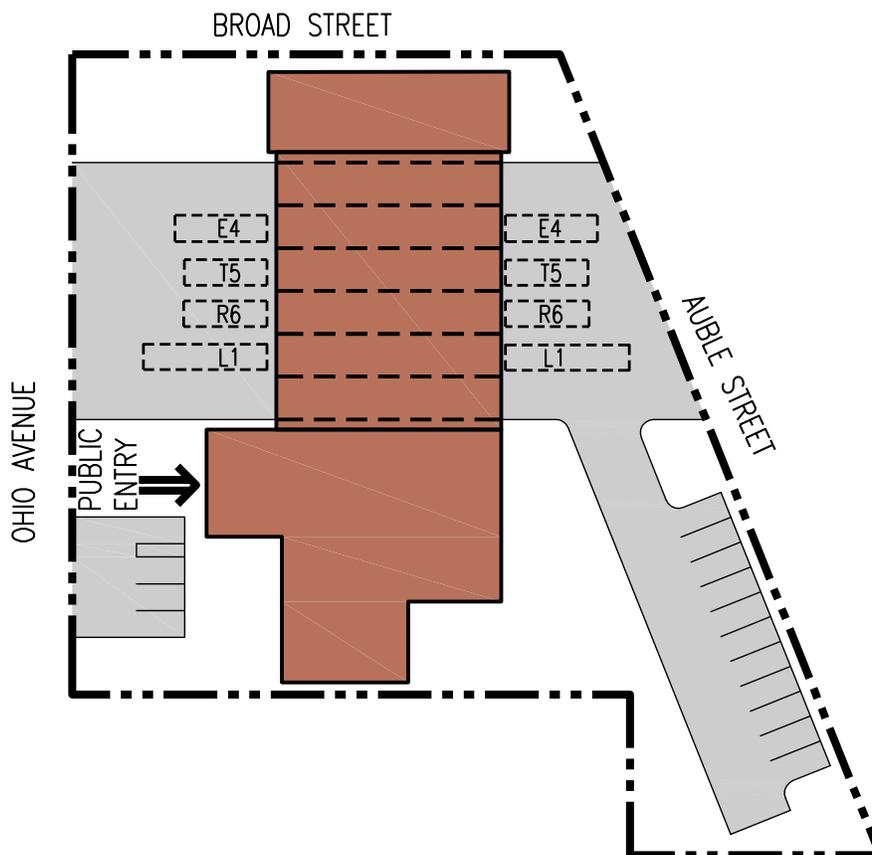
**Figure IV-3: Site 8 Diagram**

The site plan diagrams are used to determine the viability of each potential site location and floor plans are only conceptual and used to depict possible layouts or configurations. Key factors considered include:

1. Access to main thoroughfare
2. Adequate apron space between apparatus bays and main thoroughfare
3. Access for drive-through bays with adequate turning radii for the largest fire truck
4. Parking for firefighters
5. Parking for public
6. Access to public entrance
7. Space for future expansion
8. Space for on-site training

**PRIMARY RECOMMENDED SITE: Site 8: 289 Broad Street, is just east of downtown and adjacent to the City Service Facilities. This is one of the two recommended sites. The location provides excellent response times to the central part of the fire district, very similar to the current facility location, and has good proximity to on-call responder residences. The negative for this site is the fact that there is no clear room for expansion. Additional residential lots to the south would need to be purchased in the future if expansion was necessary.**

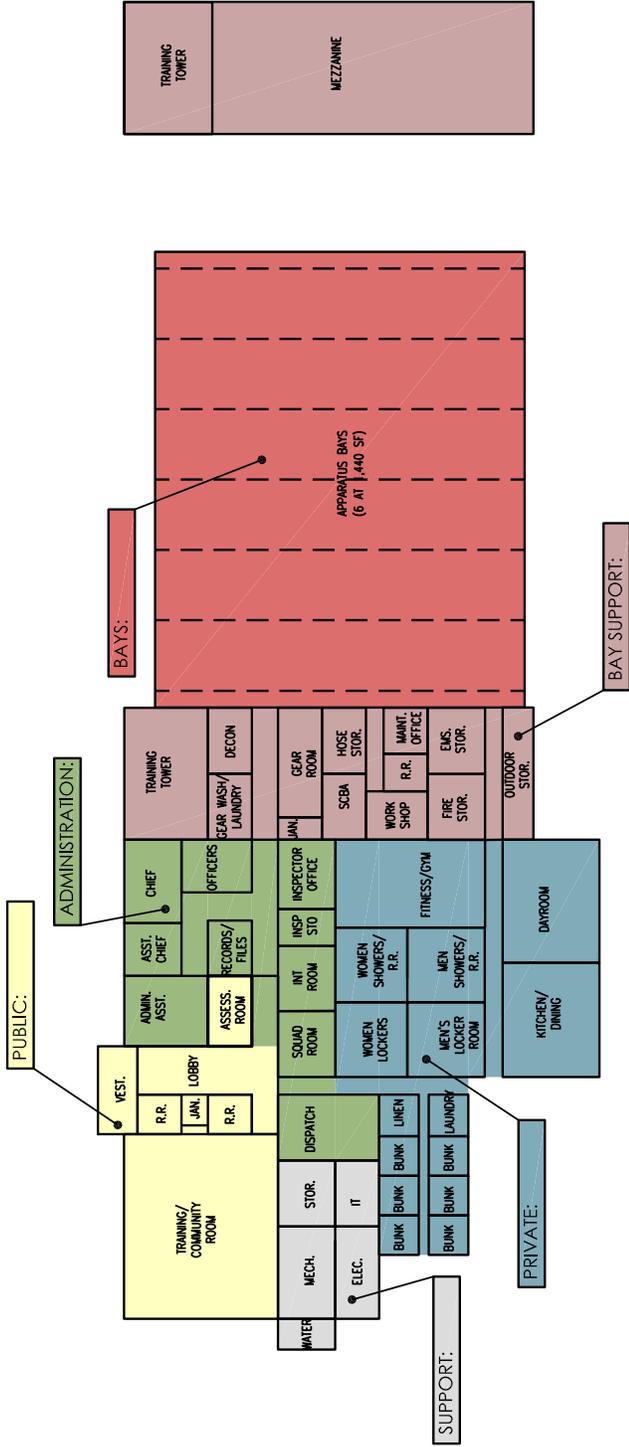
FLOOR ONE

MEZZANINE
